The Medieval Churchyard Cross at St. James' the Great Church, Colwall – Andy Ball

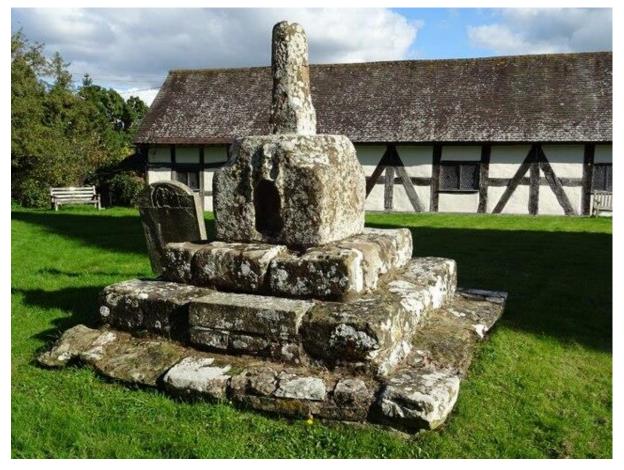
Colwall St James' the Great Churchyard Cross in 2020. Photo copyright Philip Halling.

The Colwall churchyard cross is typical of many others in Herefordshire as it is a modest, composite structure made of local stone; in sight of a porch entrance and to the south side of the main church.^{ix}

In structure and form it is also like many other Herefordshire examples. It has a roughly rectangular base of several steps, supporting a roughly square socket stone chamfered on top to an octagon into which the remains of part of a tapering stone shaft remain. Some of the stone shaft is missing, as is the capital which would have supported a stone head.[×]

The Colwall churchyard cross was Grade II* listed in 1952 under List Entry Number 1349729. The listing description is 'Churchyard cross C14-C15. Sandstone, 3 steps to base, topped by stone block, chamfered on top corners, semi-circular headed niche to west face. Above the block the stump of a shaft. This type of cross occurs at Coddington (q.v) Clifton-upon-Teme – cf under Clifton upon-Teme CP. Listing NGR: S07392242292.'xxviii

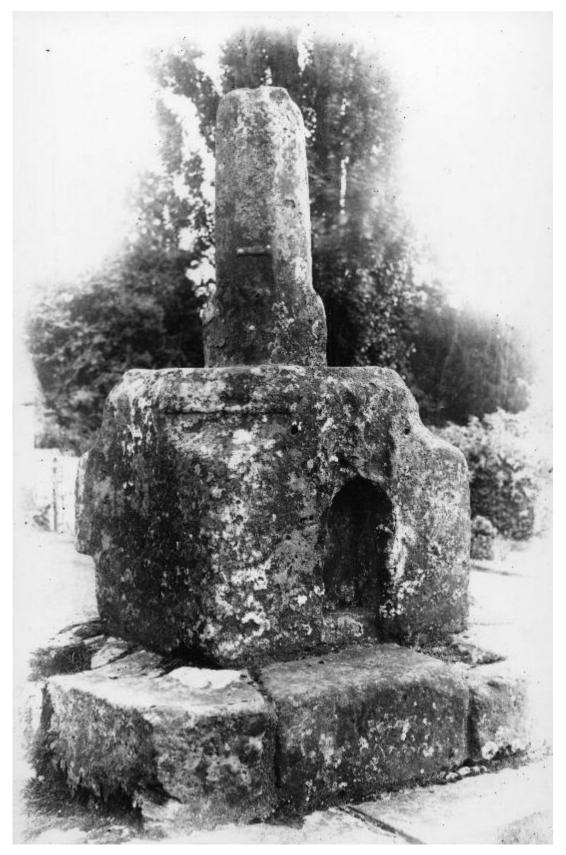
Colwall churchyard cross as photographed by Alfred Watkins in 1917.

Watkins surveyed the Colwall churchyard cross and noted the following – 'COLWALL. South of chancel. STEPS, square, 9ft. 0in. x 1ft. 0in. deep, worn. SOCKET STONE, square to octagon, 2ft.

10in. x 2ft. 6in. high, hollow bevel corners. SHAFT, 10 1/2in., square to octagon, 2ft. 7in. stump, small tongue stop and horizontal bar above it on the bevel. NICHE, round-headed, with pinnacle decoration above opening, 15in. x 7 1/2in.'^{xi}

The niche referred to was quite a common feature found on 39 of the crosses that Watkins surveyed in Herefordshire. Niches are found in the socket stones and are typically 2 $\frac{1}{2}$ to 3 $\frac{1}{2}$ inches deep. Usually, they are plain, but in Colwall the niche on the churchyard cross is decorated or moulded. B J Marples subsequently carried out a more comprehensive survey of niches on churchyard crosses writing up his findings in an article for the journal of the Woolhope Club in a piece titled *The Niches in Medieval Churchyard Crosses* published in 1972. For Colwall his survey recorded – 'Colwall. Three square steps, base and stump of shaft. The base is 4-8 with concave sloping chamfers with a bar above. The niche has a bluntly pointed top with a canopy above. This has a large crocketted pinnacle in the middle and a small one on each side. Height 141 ins., width 71 ins., depth 5 ins.' ^{xii}

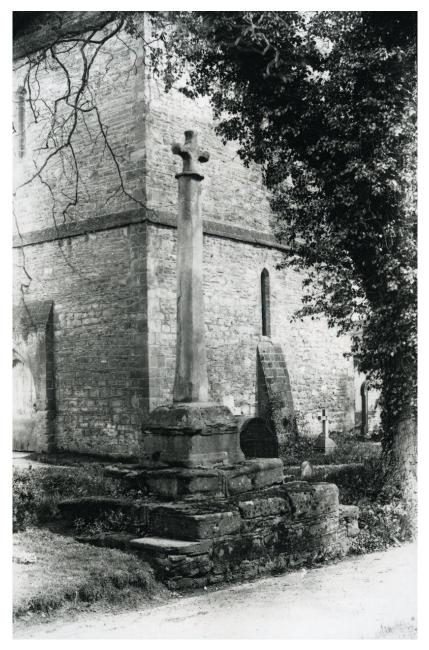
Bosbury Churchyard Cross as photographed by Alfred Watkins in 1917

Close to Colwall, at village of Bosbury, the churchyard cross was spared by the intervention of the local vicar as recorded by Bentley, in his *History of Bosbury* (1891 edition, p. 19). He relates of the churchyard cross 'It is said to owe its preservation, when others elsewhere were more or less destroyed, to the circumstance that the then Vicar of Bosbury (Rev. G. Wall), pleaded for it successfully with the captain of the Parliamentary soldiers who were sent to mutilate it, the condition being imposed that the words— HONOUR NOT THE X BUT HONOUR GOD FOR CHRIST— should be engraved on it.^{xxiii}
